1988/1989 GL1500 SADDLEBAG WATER LEAKAGE

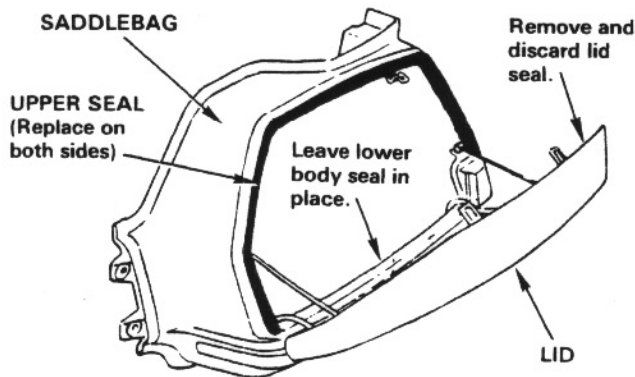
Some 1988/1989 GL1500 owners may complain about water leakage into the saddlebags while riding in the rain or washing the motorcycle.

An improved saddlebag body seal is now available. The new seal is preformed and thicker, eliminating the need for the lid seal.

1. Remove and discard the left and right upper saddlebag body seals. Leave the lower body seals in place (both sides).

2. Remove and discard both lid seals.
NOTE: The lid seal is not required with the new, thicker body seal.
3. Remove any glue residue on the saddlebags or lids.

4. Attach the new seals using Hondaline Weatherstrip Cement (H/C: 1724426), 3M Fast-Tack #08031, or equivalent. Follow the manufacturers directions to assure complete drying.

5. If necessary, adjust the latches so the lids will open and close easily.
